**SYSTEM
SOLUTIONS
ENGINEERING**

PORT AUGUSTA GENERATOR FAILURE

INVESTIGATION REPORT

Date: November 2016

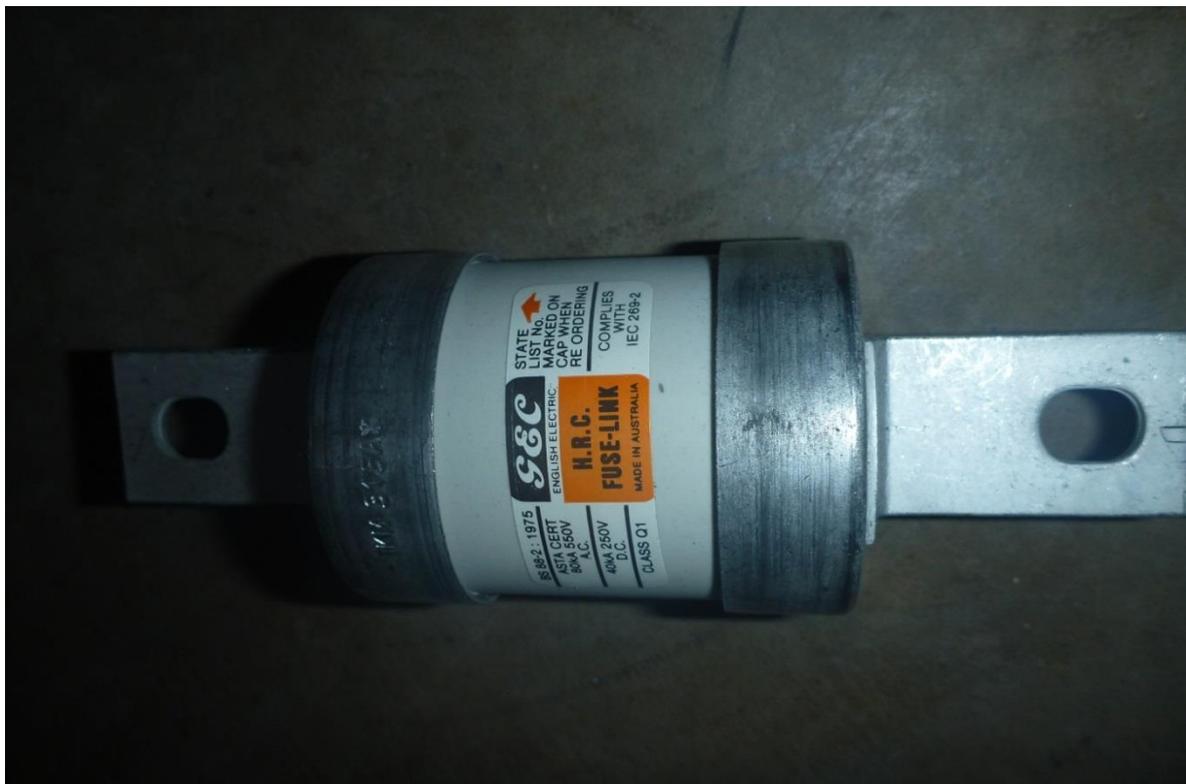
The output from the controller is rated at 170 Kilowatts and the controller is actually protected by 315 amp fuses and as can be seen from the figures in table 1, the engine and alternator should be capable of providing considerably more than the maximum load the fuses are designed to protect against.

As a percentage of the engine output the control panel is approximately 78% of the engine Kilowatt capacity, so at approximately 300 amps of load the engine should only be producing approximately 78% of its power capacity.

315 Amp Fuses Protecting the Output of the Generator

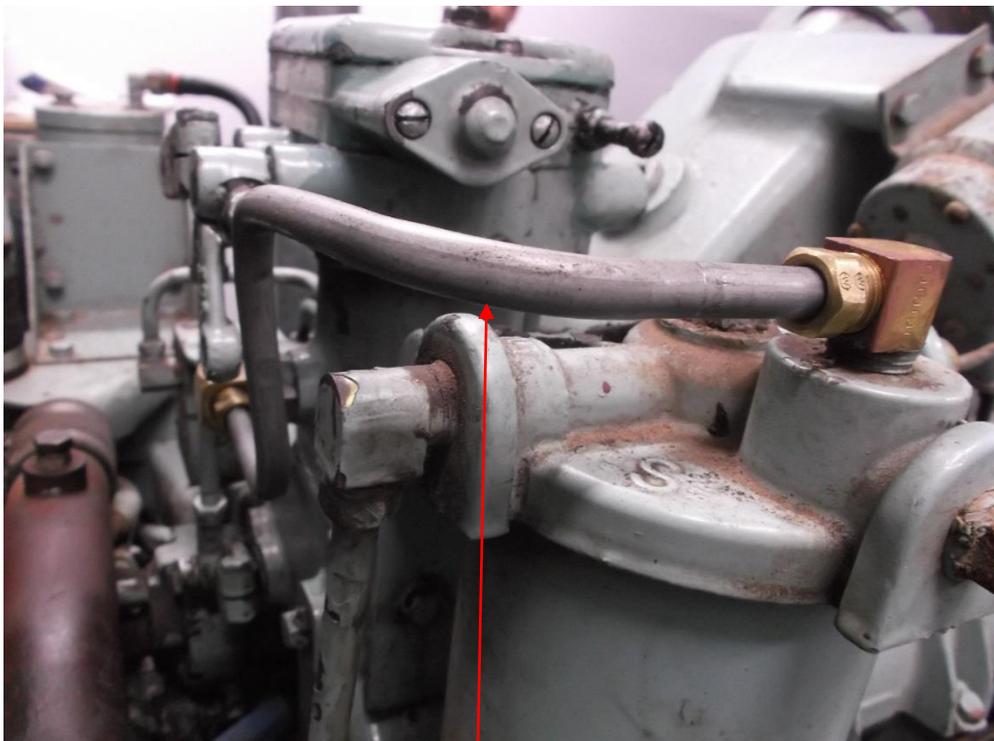
Butler Mechanical services said that they found a thread at a connector had been stripped at some stage when this pipe had been removed and reinstalled. This meant that the fitting was loose and that through vibration etc a rupture developed at a weak point in the pipe (a bend in the pipe).

Oil pipe that was replaced by Butler Mechanical Services

Butler Mechanical services manufactured a new pipe and installed it to the generator which took approximately 2-1/2 hours.

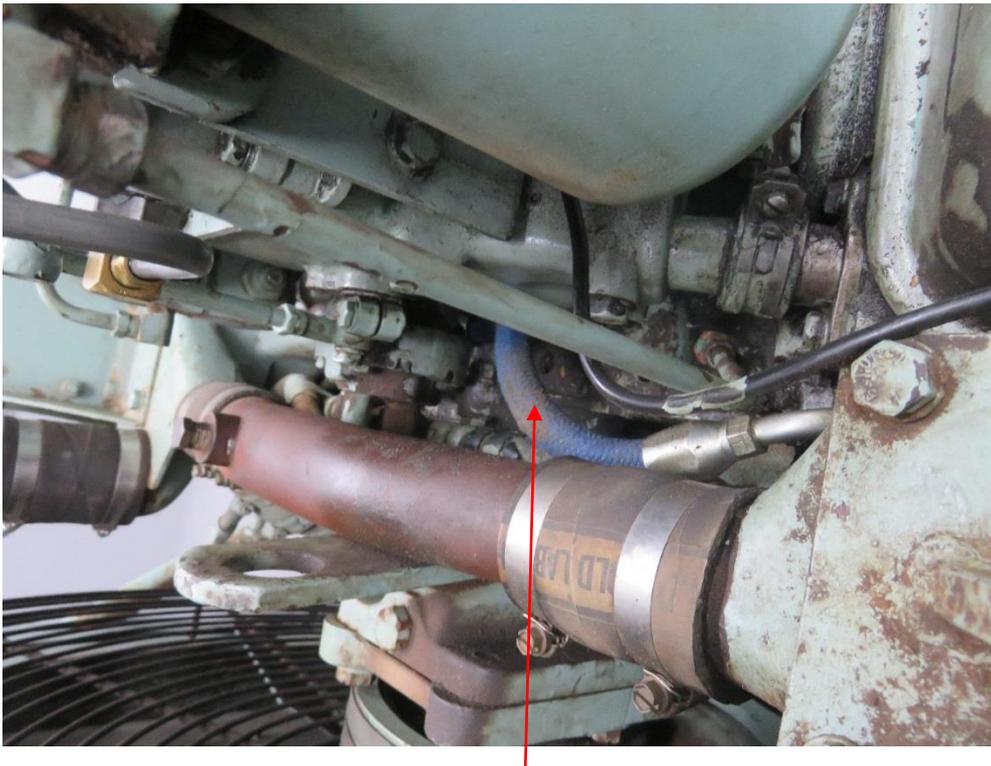
Approximately 1-1/4 hours after the generator was put back into service after the oil leak was repaired, another leak developed which turned out to be a rubber diesel fuel line that ruptured at the front of the generator engine.

We believe that the ruptured fuel line was the original fuel line making it 44 years old and over time had become brittle and reached a point where it failed and ruptured.

Fuel pipe replaced by Butler Mechanical Services

The generator was immediately shut down and Butler Mechanical Services were called out to repair the ruptured fuel line which took approximately 4 hours.
